PHOTO SHEET

LOCATION Austin, Texas
DOCUMENT NO. F/U to F9837026A
PRODUCT Himalaya Amusement Ride
IDI# 980320CWE7133

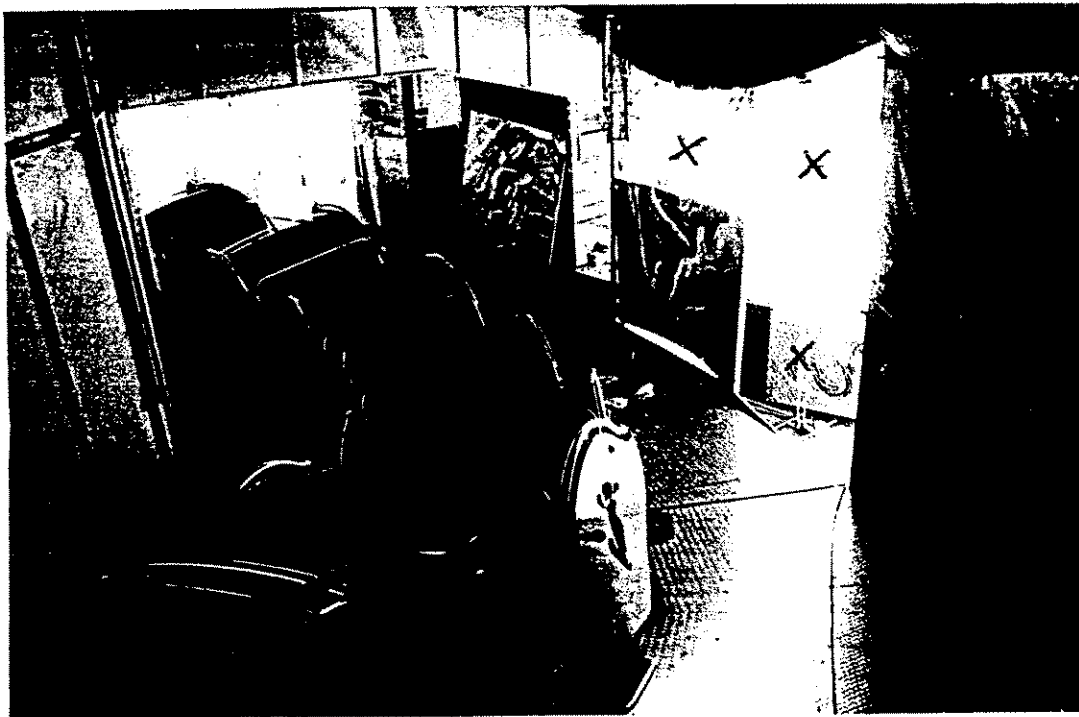
NO. 21

Photo shows the incident area from the twelve o'clock area looking back down onto the site. The panels missing from their usual location were removed to allow entry by paramedics. "X's" mark the area where panels were removed.

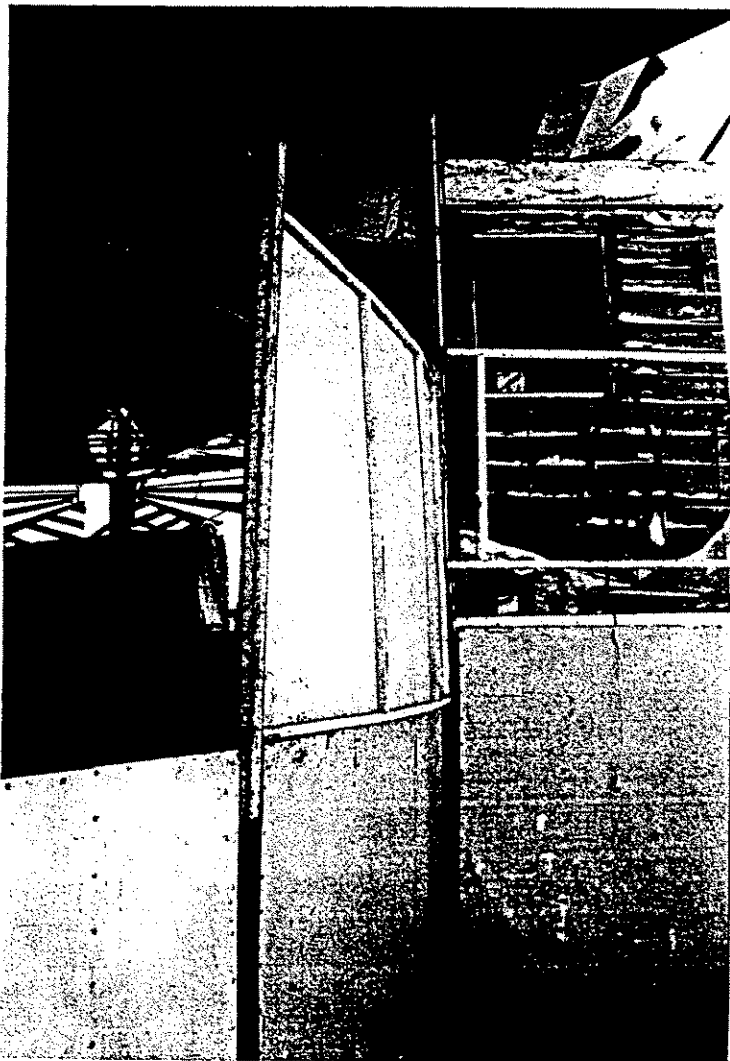
NO. 22

Photo shows panel the victim hit from the outside of the ride. Note the bulge at the bottom of the panel. The window in the photo part of the ride operator's station. As can be seen in this photo and photos 18-21, this incident occurred almost in front of the operator's station.

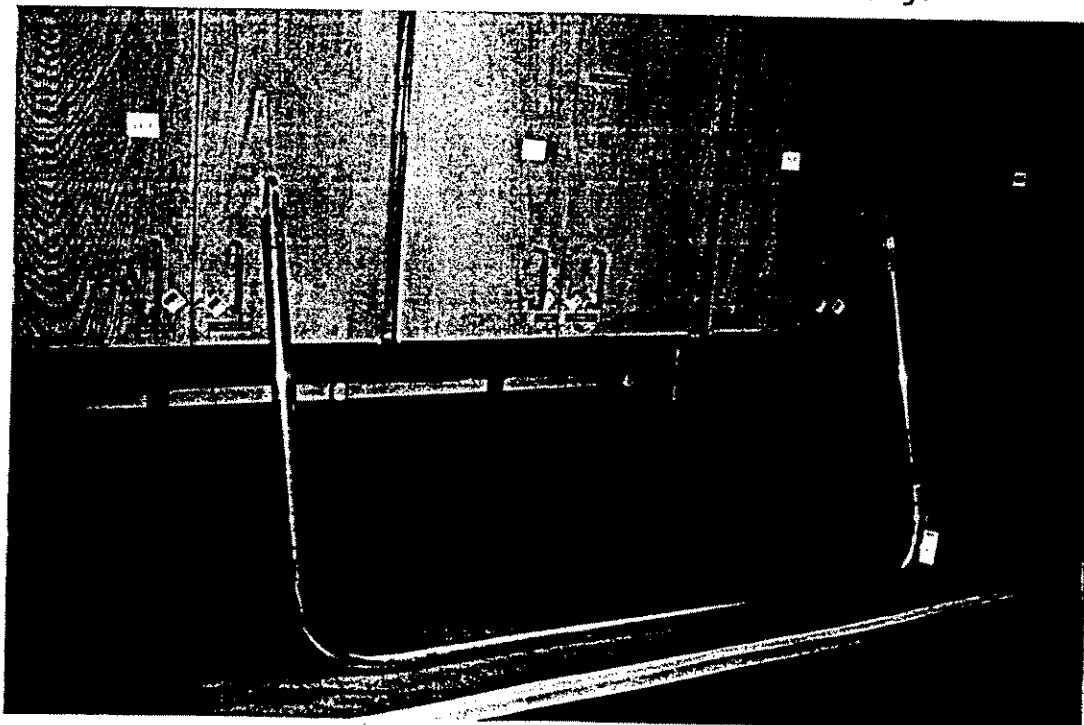
NO. 24

Photo shows the lap bar removed from the scene by local police.

The lap bar was part of car 19 the victims were in and came out of the car with the victims when they were ejected. The bar is 46 7/8 inches wide and the two short parts which attach to the inside of the cars are approx. 28 inches long.

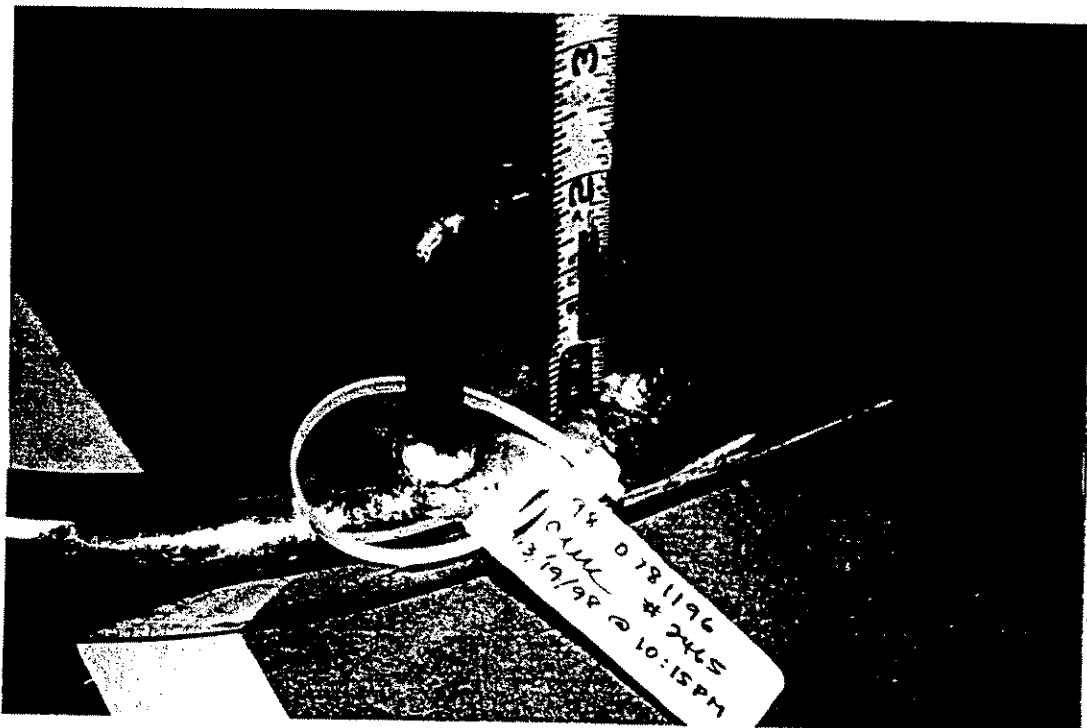
NO. 25

Photo shows the part of the lap bar which allows the bar to become secure in the locking mechanism of each car. The tape measure shows the approx. size. This photo was taken in the police evidence room.

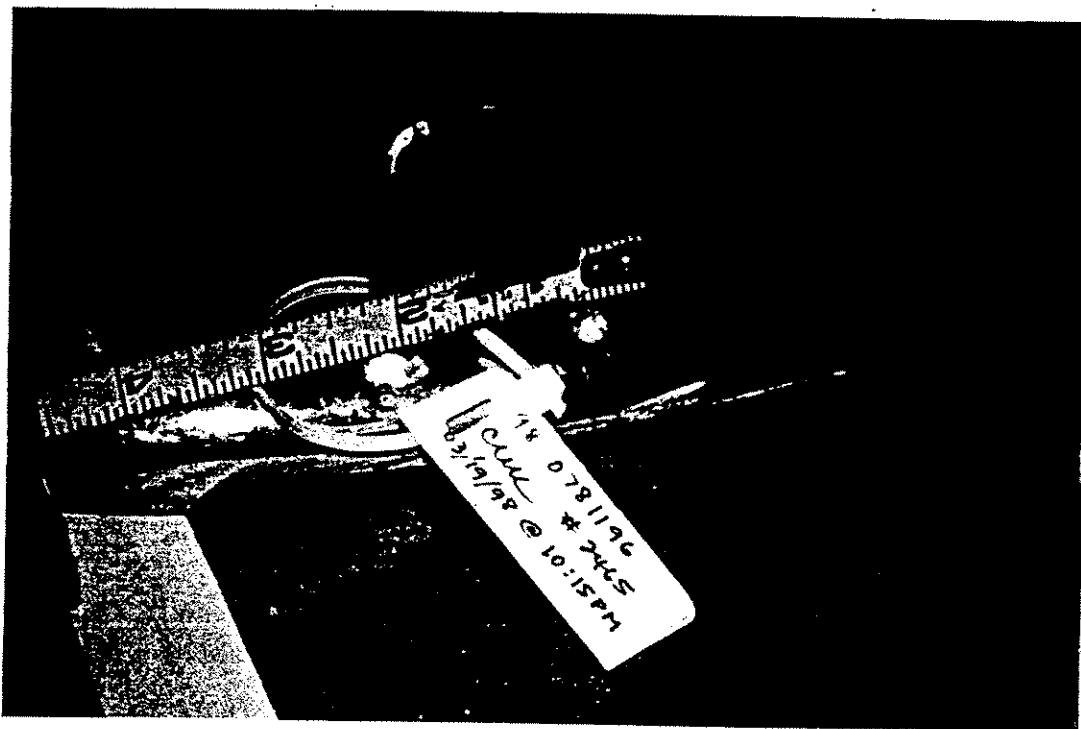
NO. 26

Photo shows
another
measurement of the
part of the lap
bar shown in photo
25. This photo
was also taken in
the police
evidence room.
Other photos of
the lap bar are
attached with this
report.

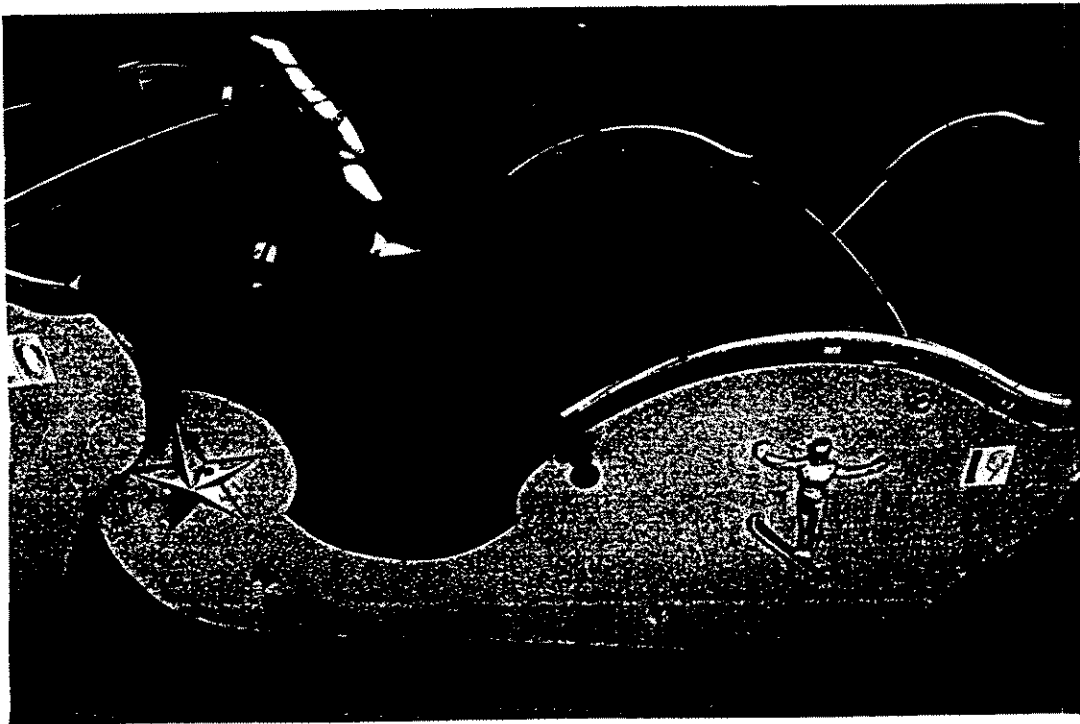
NO. 28

Photo shows overall view of car 19 the victims were in. Note the lap bar is gone. The ride was roped off as a crime scene and remained under a 24 hour guarded watch. This photo is of the car as it was when it came to a stop.

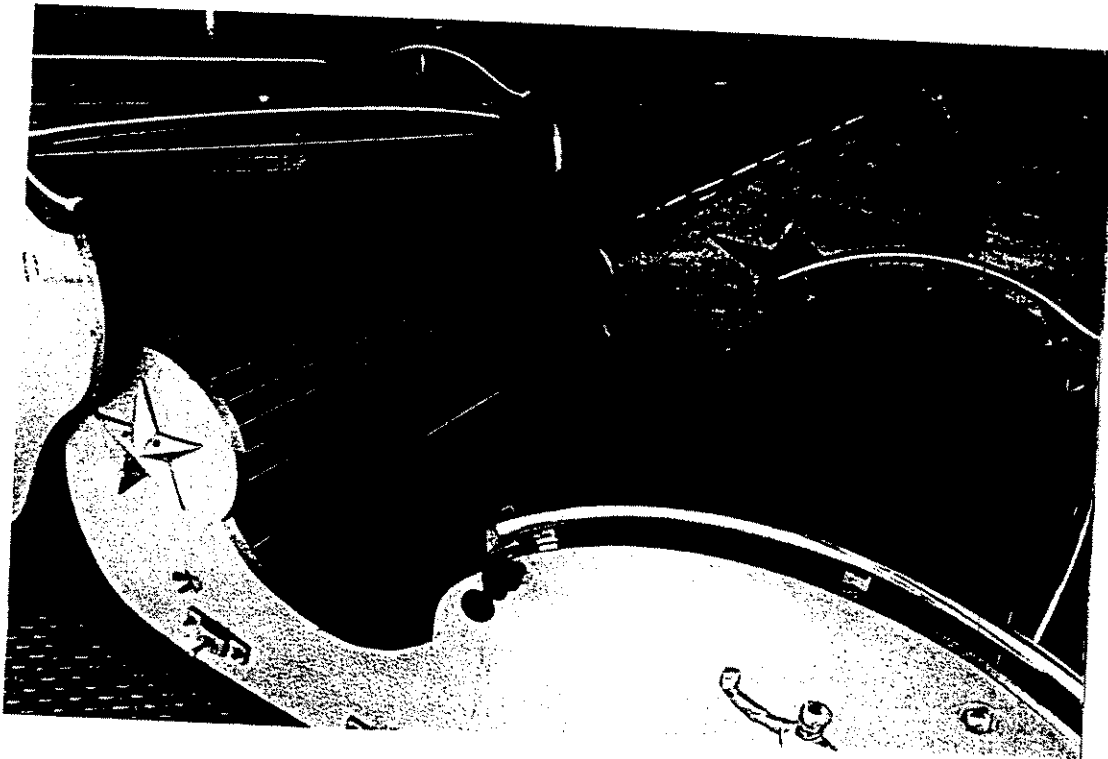
PICTURE
NO. 29
DESCRIPTION
Photo shows
another overall
view of car 19 the
victims were in.
Note the lap bar
is gone.

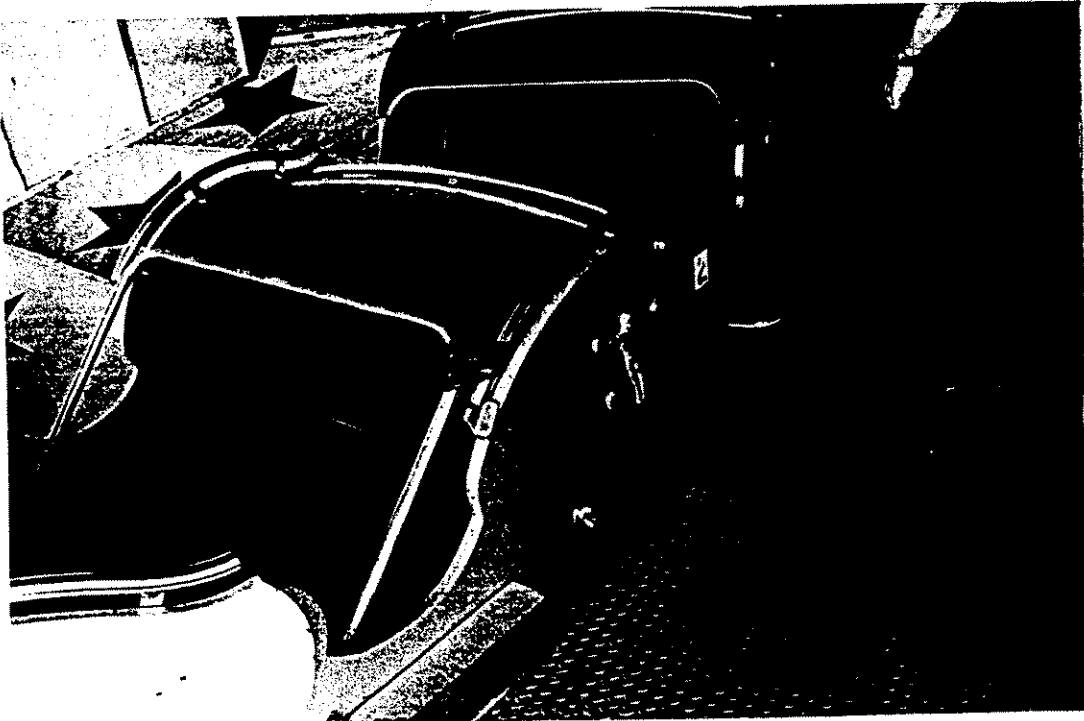
NO. 47

The inspection by Bob Gill prior to the opening of the ride listed cars 2, 6, 17, 24 as not to be used because of broken catches (locking mechanisms).

Photos 47-50 show these cars. This photo shows the lap bar for car 2 as having its lap bar taped down and not to be used.

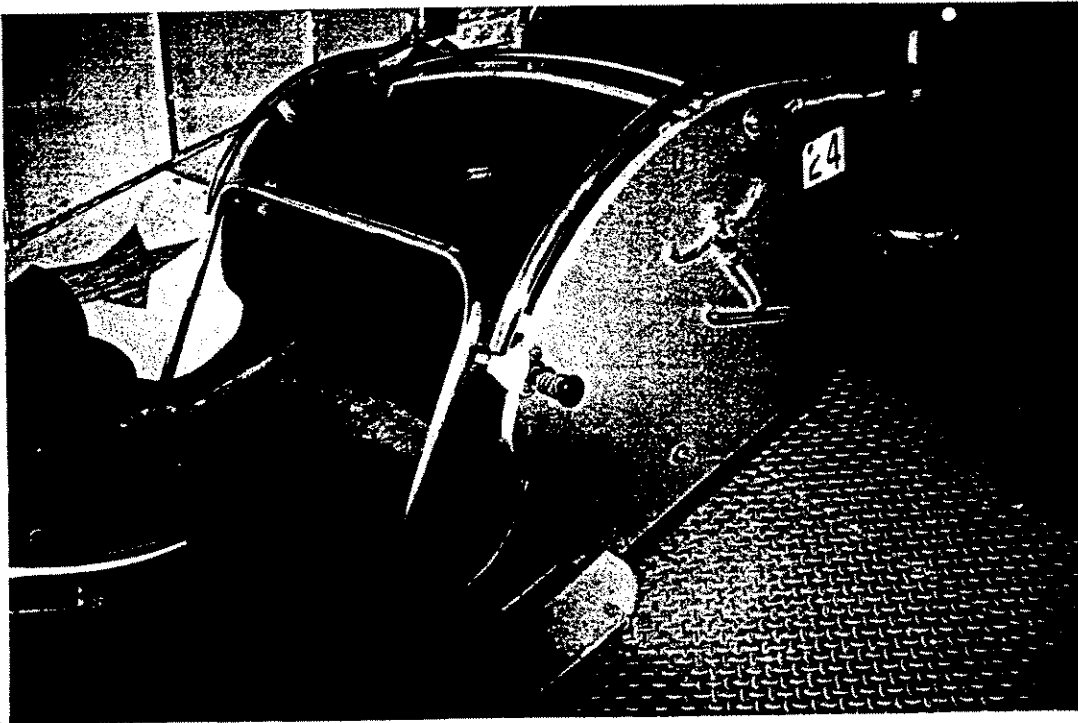
NO. 48

Photo of car 24.

The pre-inspection
listed this car as
not to be used;

however, it
appeared to
working okay when
checked. Note the
lap bar is not
taped down.

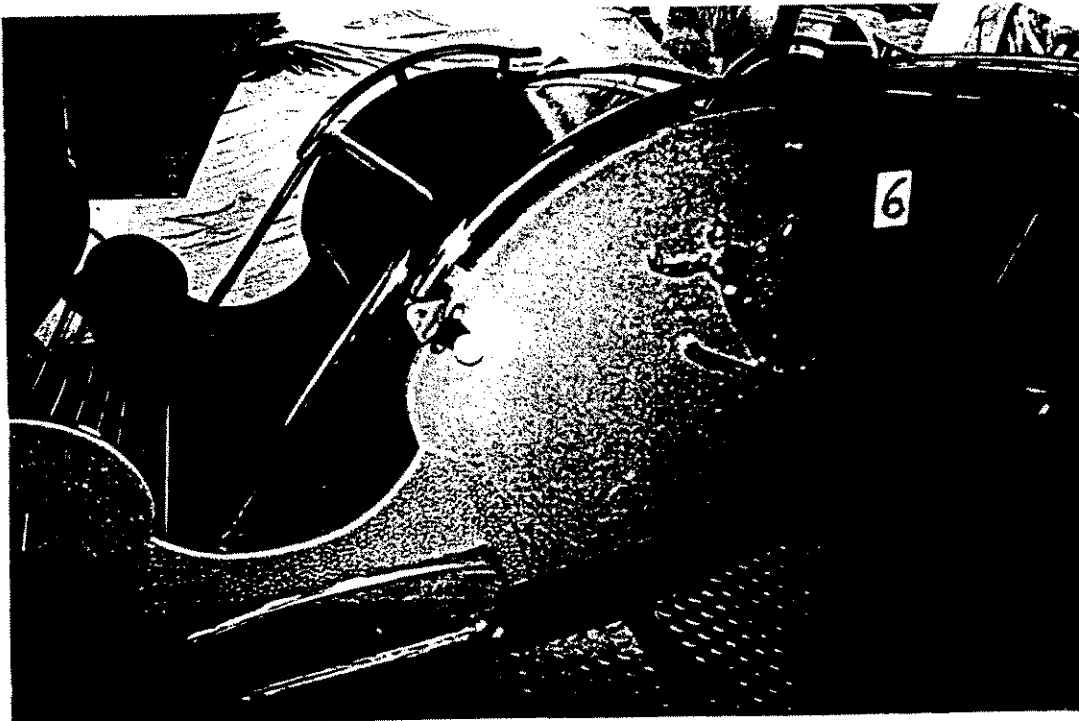
PICTURE
NO. 50
DESCRIPTION
Photo of car 6.
The pre-inspection
listed this car as
not to be used;
however, it
appeared to be
working okay when
checked. Note the
lap bar is not
taped down.

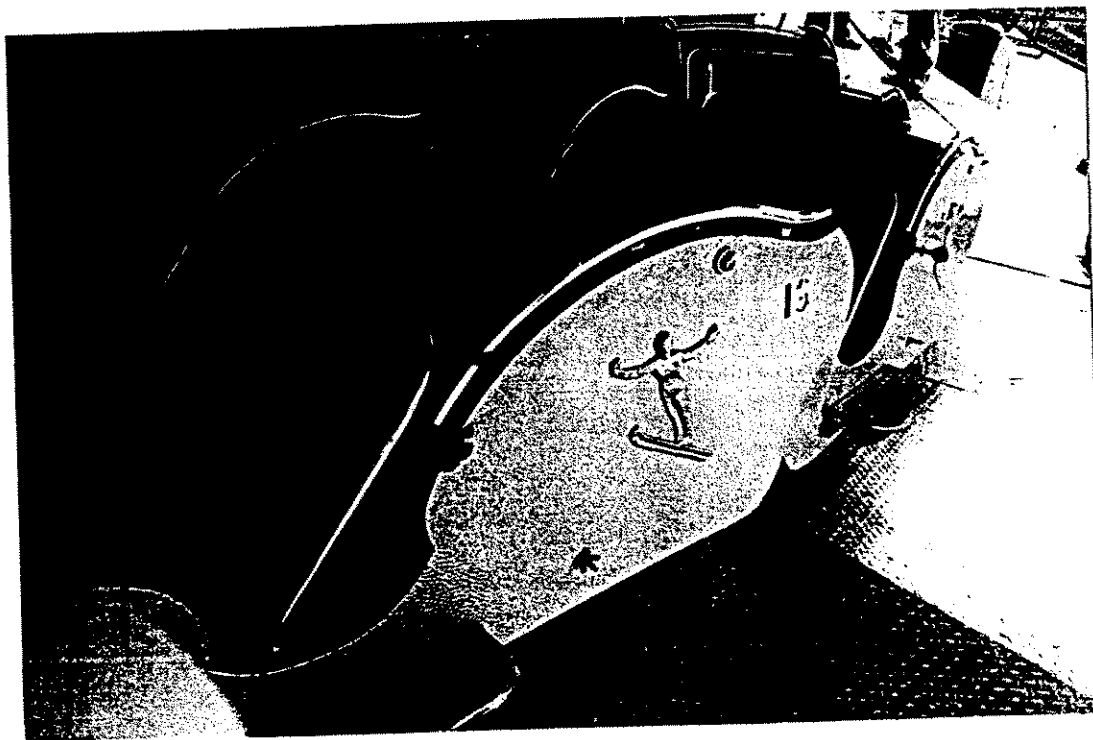
NO. 51

Photo of car 13.
The pre-inspection
did not list this
car as having a
broken locking
mechanism and not
to be used;
however, as can be
seen the lap bar
has been taped
down and the
locking mechanism
is missing.

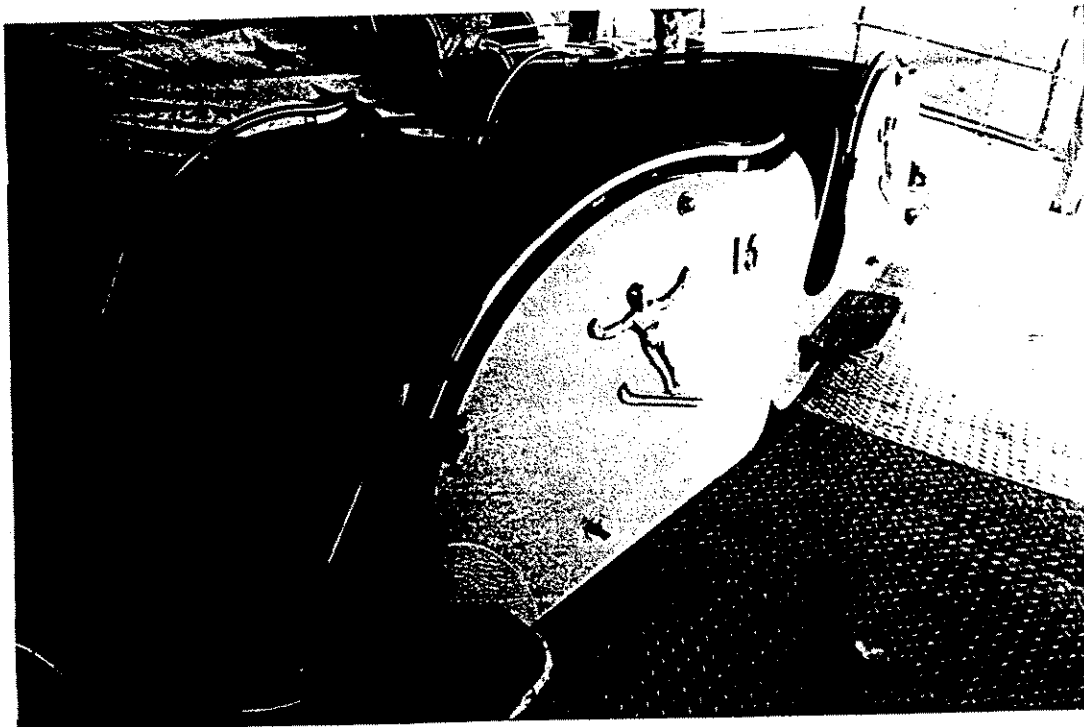
NO. 52

Photo of car 16.
The pre-inspection
did not list this
car as having a
broken locking
mechanism and not
to be used;
however, as can be
seen the lap bar
has been taped
down and the
locking mechanism
is missing.

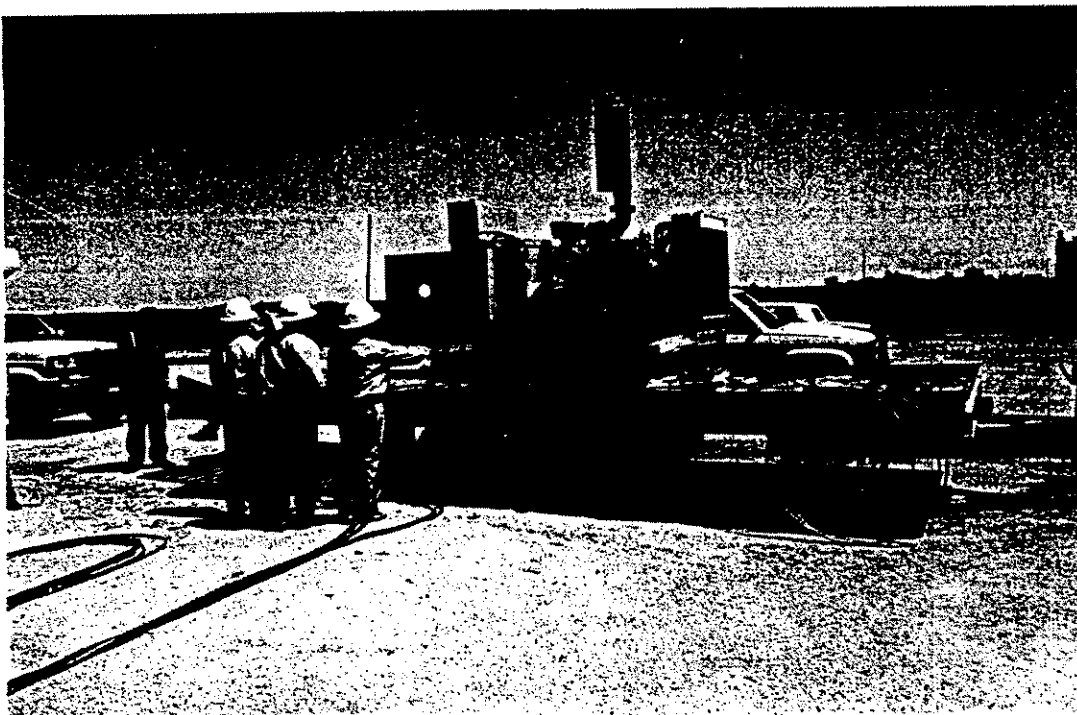
NO. 53

On March 27, 1998,
the ride was run
to check its
performance. The
main test was to
count the number
of RPMs. Photo
shows a generator
brought to the
scene for the
purpose of getting
power to the ride.
The generator was
provided by the
city of Austin.

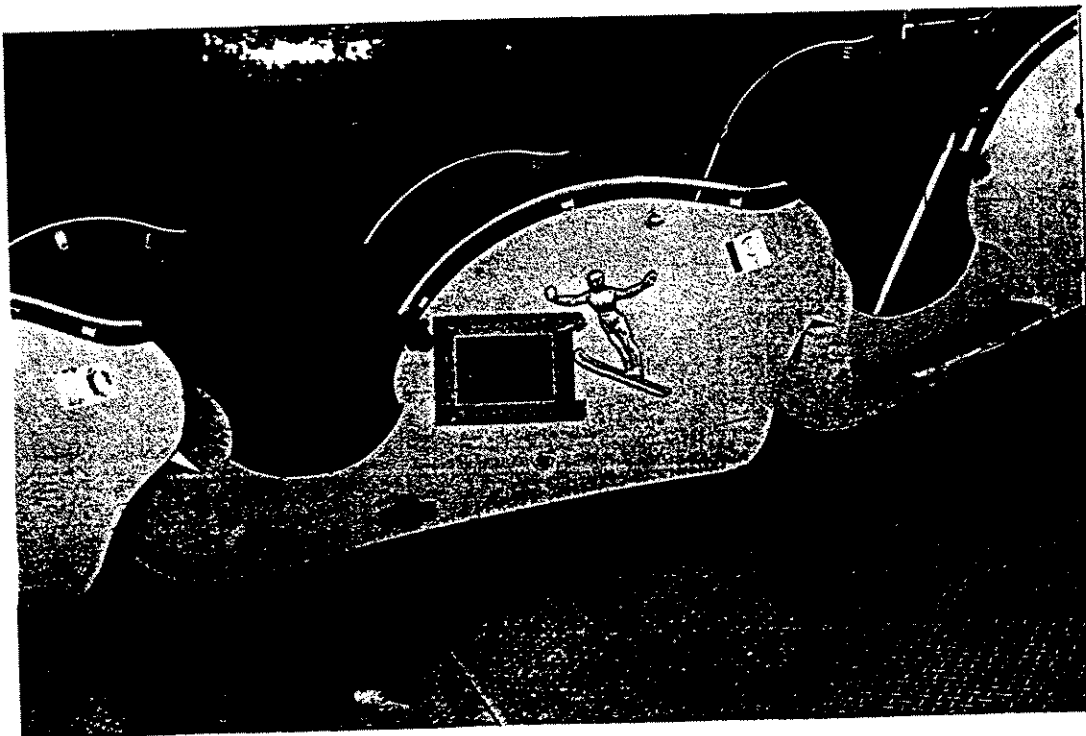
NO. 54

Car 19 was marked with the bright pink sign for the purpose of counting the car as it came. An operator was found to operate the ride who was not affiliated with B & B Amusements or the city of Austin. The ride was supposedly set to go 10 RPMs at maximum speed. The ride is designed to go forward or backward, but this ride would only go forward.

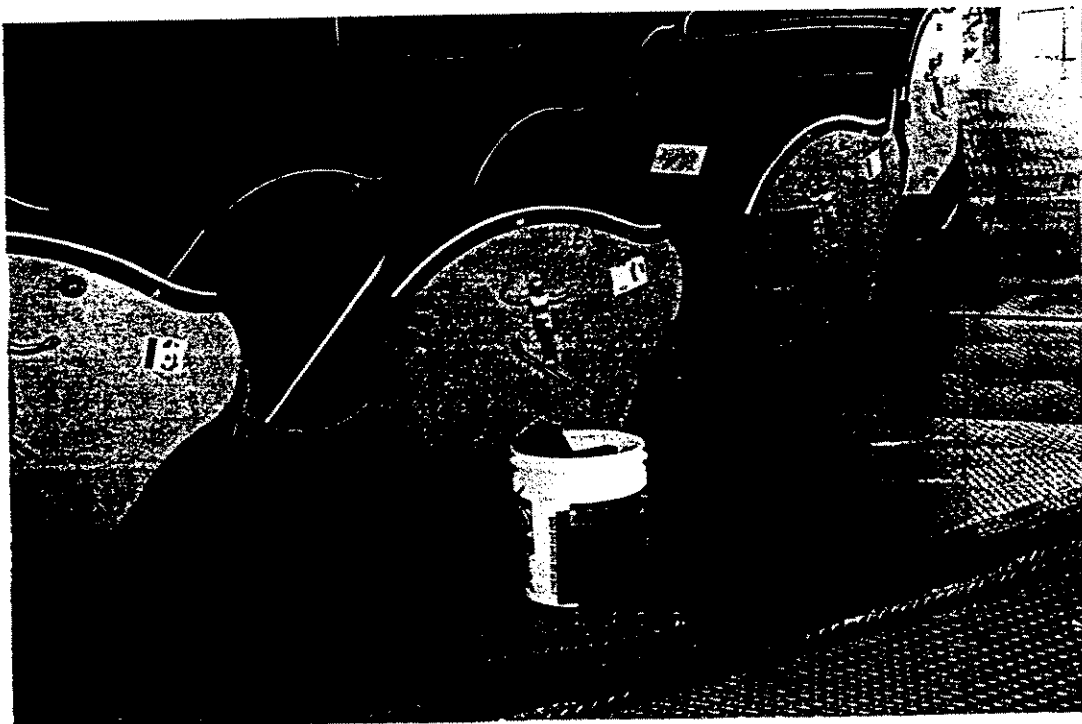
NO. 55

Car 19 was also marked with the bright yellow sign on the back of the seat. The white bucket with the pink sign was placed there to line up the marked car as it came by. The car was tested with a stop watch and counting revolutions and also by a video camera. At maximum speed the ride went constantly at 15.789 RPMs or one revolution every 3.8 seconds.

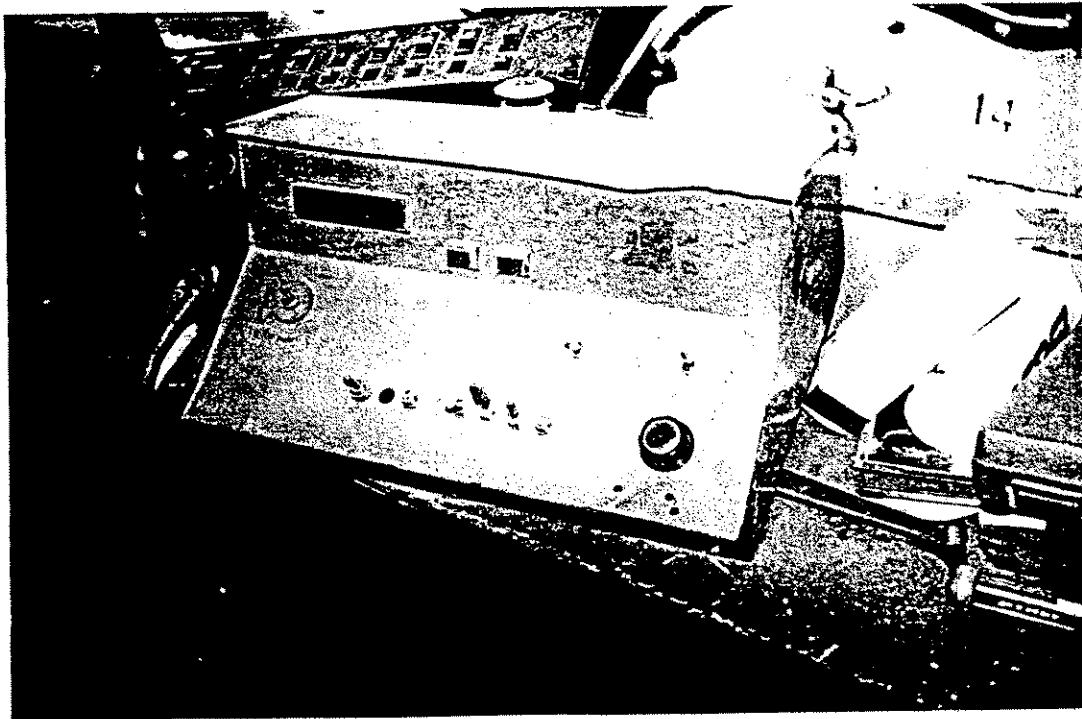
NO. 56

Photo shows the control box inside the ride operators station. The operator was watched by police and they also ran the ride at full speed. The ride was also clocked with a radar gun and it ran at a top speed of 23 mph. The ride went much faster than the 10 RPMs quoted by an official of Bob Gill & Associates.

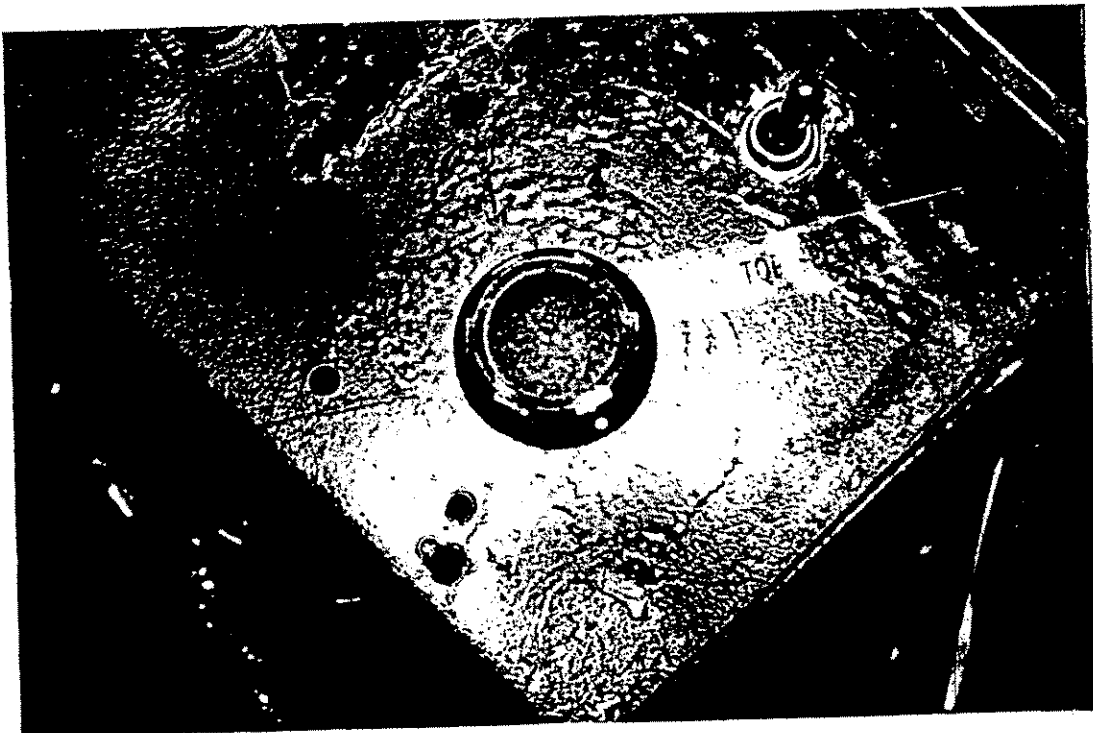
NO. 57

Photo shows a closeup of the control box inside the ride operators station. With force, the control knob would go past the TOP SPEED label because the inside of the knob appeared to be plastic and somewhat stripped. The white dot on the control knob is supposed to be the speed indicator. When the white dot went past the TOP SPEED label, it did not go faster.

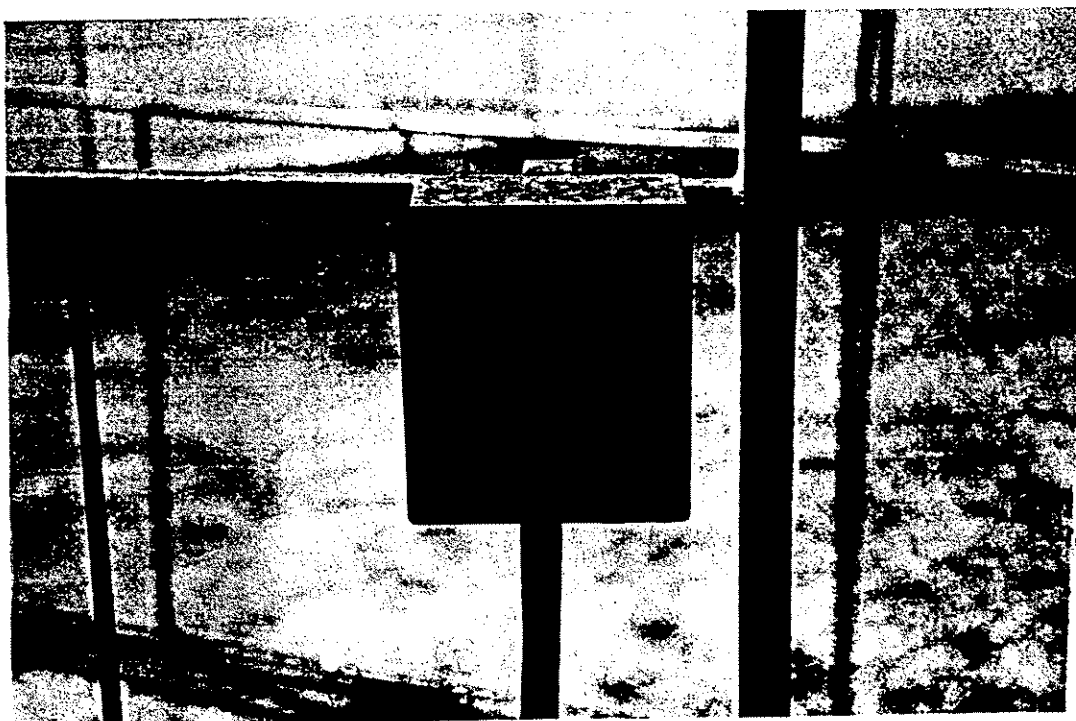
NO. 58

Photo shows a closeup of an emergency "kill switch" on the opposite side of the ride from the ride operator station. There were reports this "kill switch" was activated by one of the ride attendants. The ride also reportedly went around at least one revolution or maybe almost two before it came to a complete stop after being turned off.

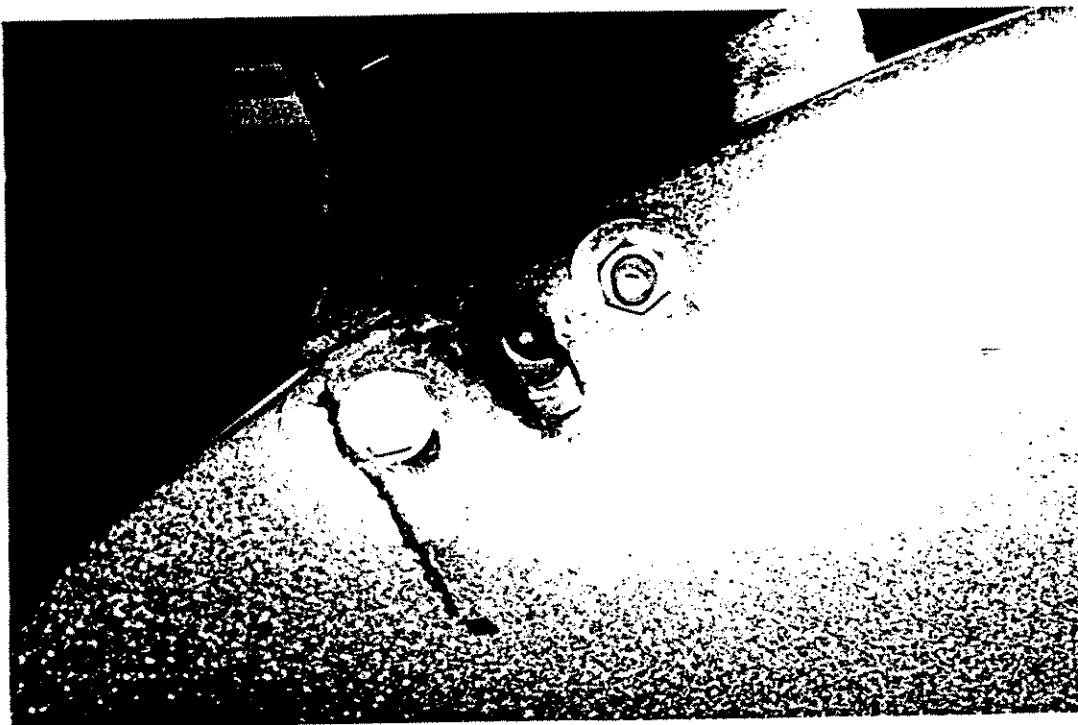
NO. 61

This photo shows
the car the part
in photo 60 came
out of while it
was being tested.
It appears the
shaft came
unscrewed from
inside the car
wall.

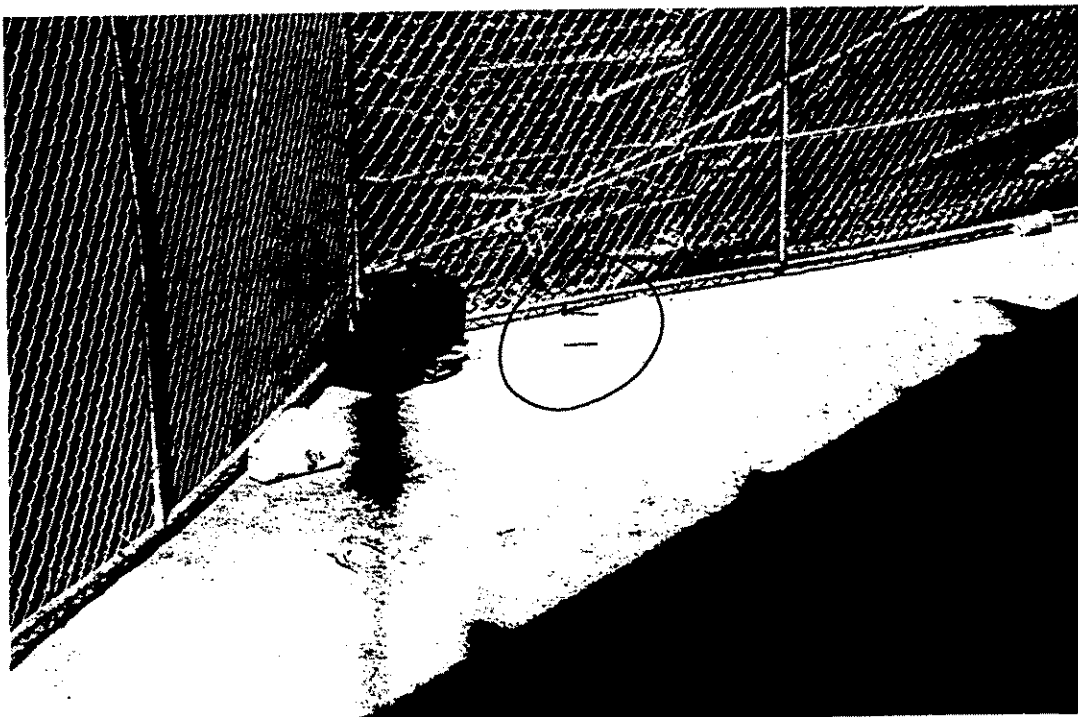
NO. 62

While conducting another test yet a third locking mechanism came flying off one of the ride's cars. This part narrowly missed this investigator and was traveling at an extreme high rate of speed. Photo shows the parts lying close by my camera case and brief case. (Note circle)

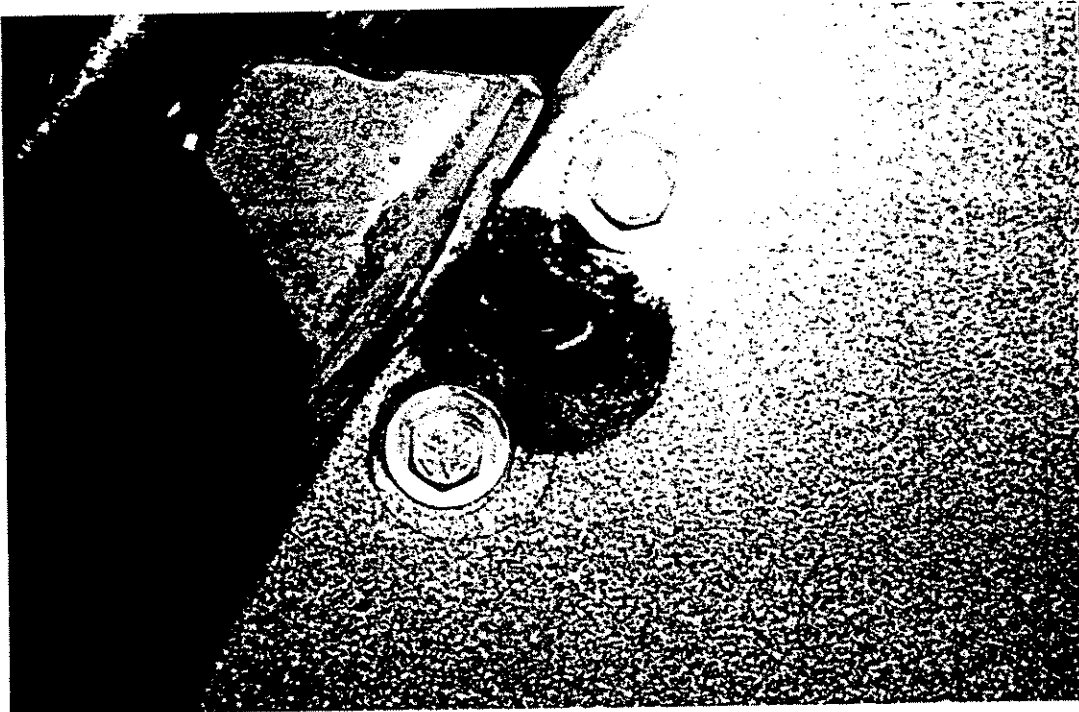
PICTURE
NO. 64

DESCRIPTION
Photo shows the
car the parts
shown in photos 63
and 63 came off
of.
